MISCELLANEOUS PAPER SL-86-5

# EXPLOSIVE TESTS ON REINFORCED CONCRETE WALLS AT CAMP SHELBY, MISSISSIPPI

July 1986  
Final Report

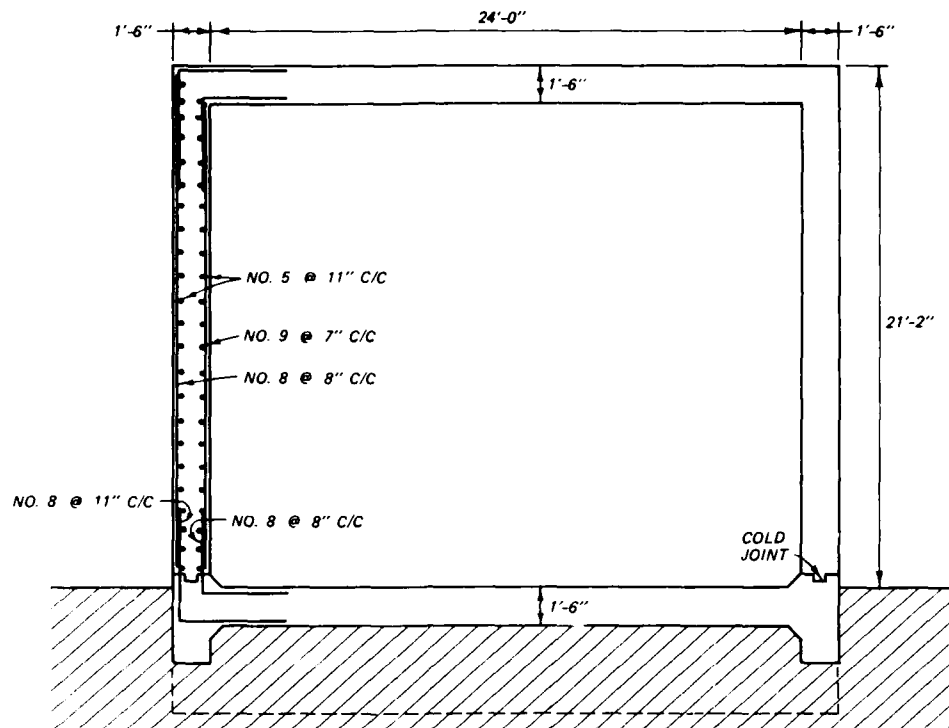
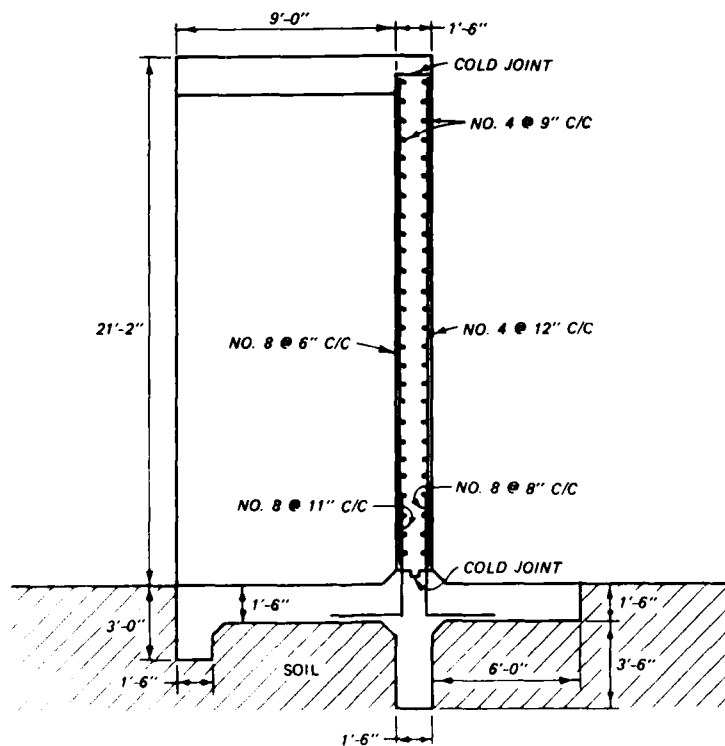
Figure 1. Structural details

a. Rear view of cross section showing rebars in one of the side walls

b. Side view of cross section showing rebars for front wall

5. Sketches of structural details are given in Figure 1. The vertical steel reinforcement in the front wall consisted of No. 8 bars on 6-in.\* centers for the interior face and No. 4 bars on 12-in. centers for the outside face. Therefore, the reinforcement ratio was 0.9 percent in the interior face and 0.11 percent in the exterior face. Horizontal reinforcement consisted of No. 4 bars on 9-in. centers in each face for a 0.17-percent ratio in each face. For the side wall, vertical reinforcement consisted of No. 8 bars on 8-in. centers for the exterior face (for a ratio of 0.67 percent) and No. 9 bars on 7-in. centers for the interior face (for a ratio of 0.98 percent). Horizontal reinforcement consisted of No. 5 bars on 11-in. centers (0.2 percent) in each face. There was a cold joint at the junction of the floor and walls, and dowels extended across this joint to tie the two members together structurally. The dowels consisted of No. 8 bars on 8-in. centers in the exterior face (0.67 percent) and No. 8 bars on 11-in. centers in the interior face (0.76 percent).

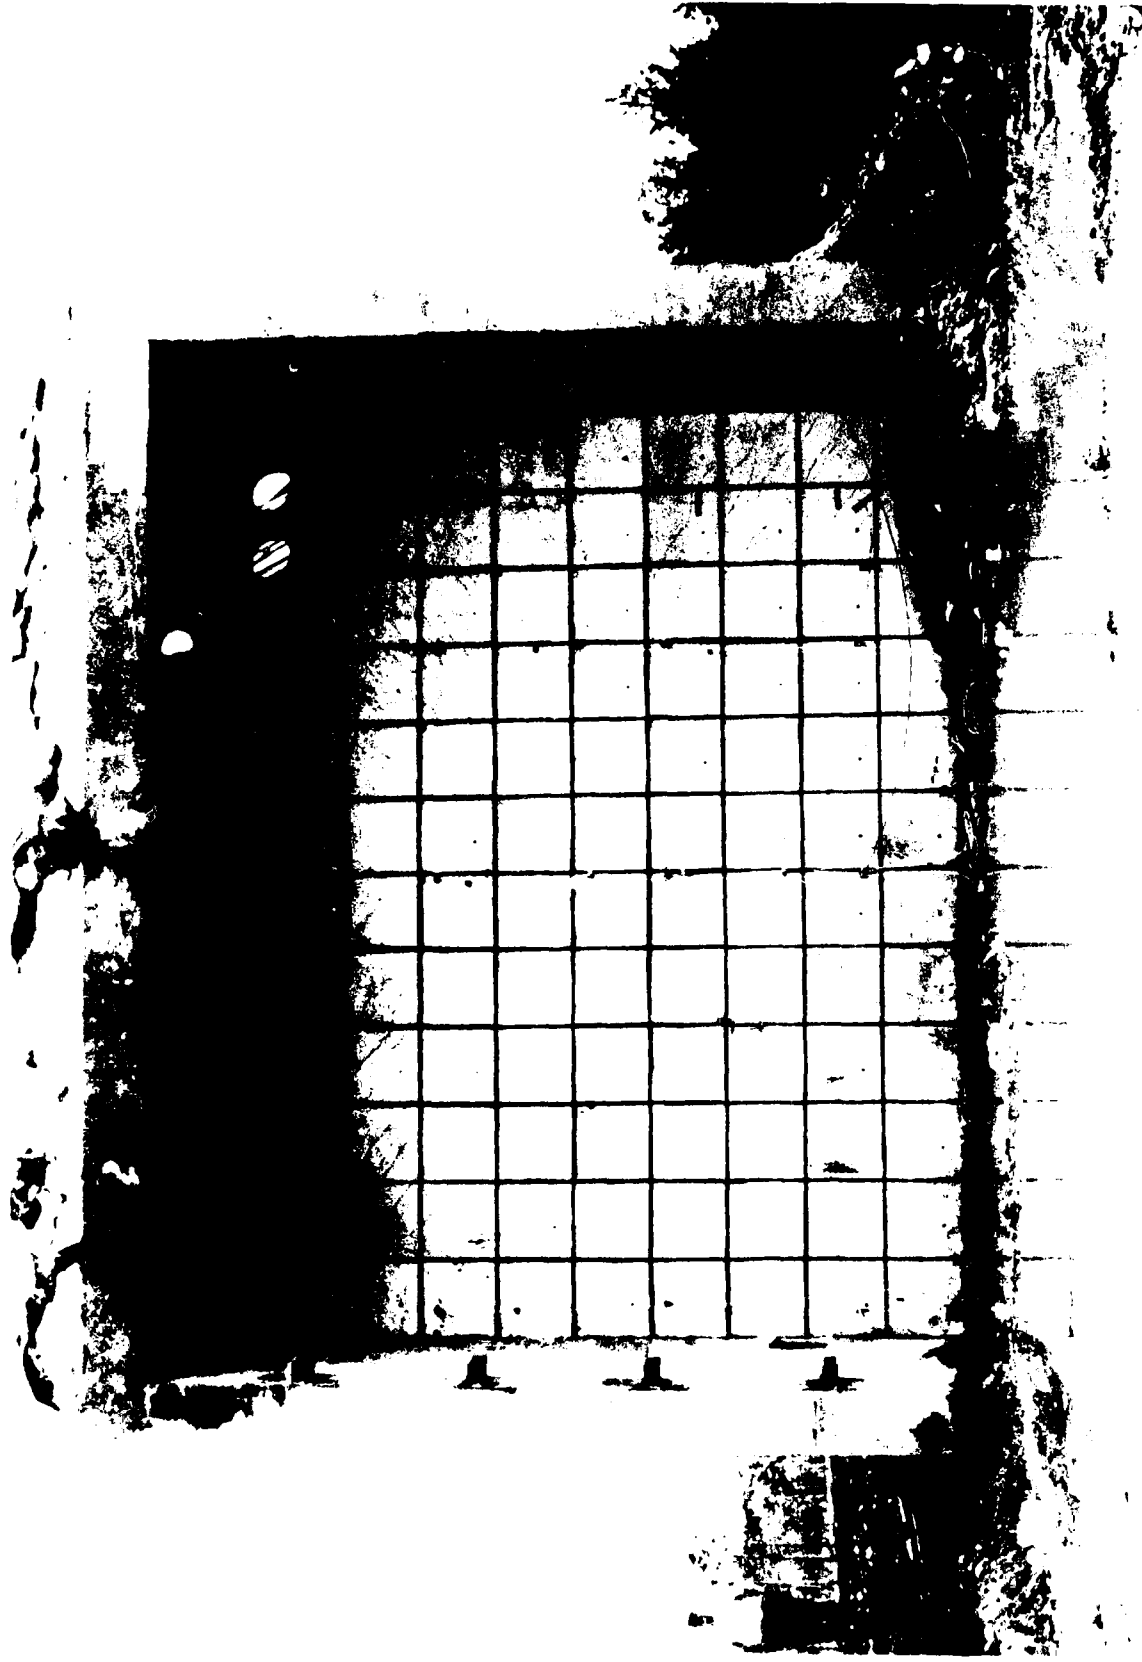
Figure 2. Existing damage to test structure as viewed from rear

6. During construction, four steel reinforcement bar samples were taken for each size bar and tested for yield and ultimate strength. The results are given in Table 1. The steel was specified as American Society for Testing and Materials (ASTM) A 615-68, Grade 60. Concrete samples were also taken during construction of the walls. The average 28-day compressive strength of six test cylinders was 4,321 psi. The walls were cast on 28 October 1982. After completion of the structure, an impact test was conducted to determine the natural frequency and mode shapes of the wall. The fundamental frequency was determined to be 48.6 Hz. As mentioned, the structure was constructed for another test program and was tested initially on 18 December 1981. This test left the front wall structurally sound with a maximum permanent deflection of only 0.05 in. and with numerous hairline cracks, as shown in Figure 2 (after highlighting with a black felt-tipped marker). The lines shown painted on the wall are 2-ft squares. No damage resulted to the side walls.

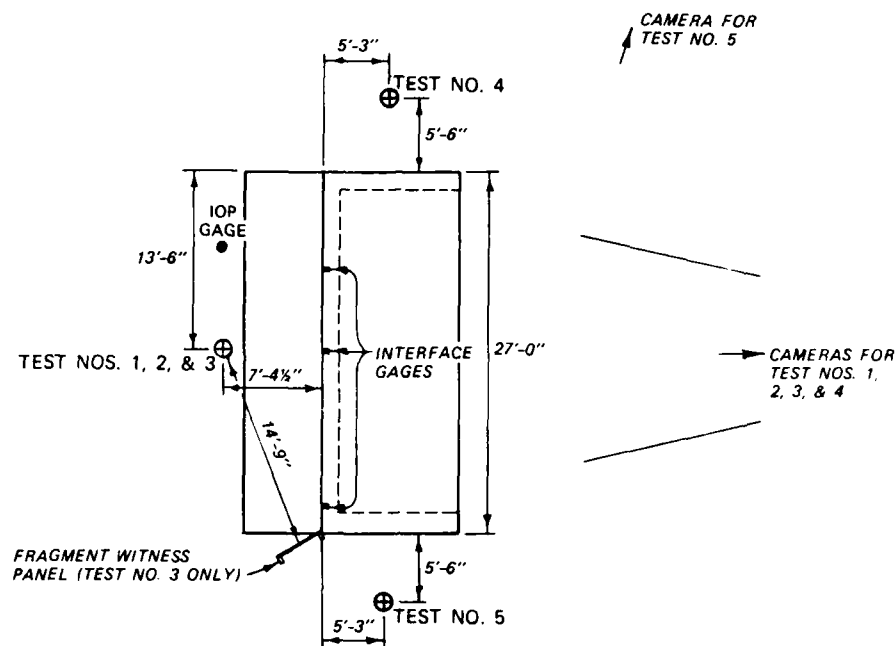
Figure 3. Test setup

7. The tests were conducted from 31 March through 2 April 1982. The setup for the tests is shown in Figure 3, and the test parameters are listed in Table 2.

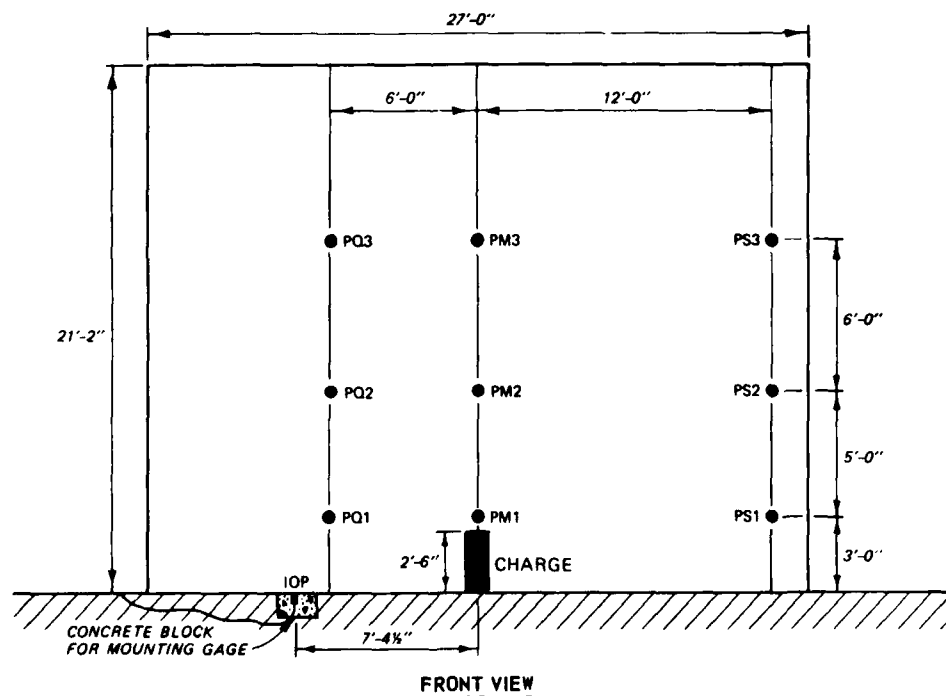
Figure 4. Gage layout for Tests 1-3

9. Instrumentation for the first three tests consisted of airblast gages placed in the front wall of the structure and an airblast gage placed flush with the ground surface. The gage layout is shown in Figure 4. All gages were Kulite Corporation Model No. HKS-375. Table 3 gives the pertinent data concerning the gages used in the test. All gages were mounted so that the gage face was flush with the exterior face of the wall or with the ground surface.

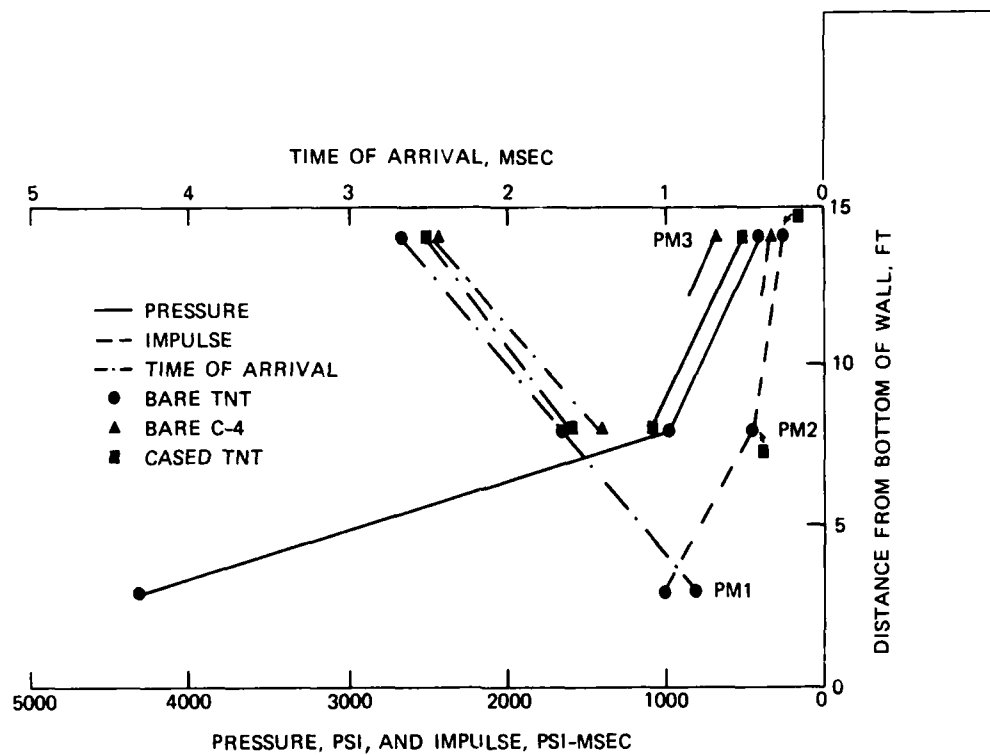
Figure 5. Comparison of blast pressure data for gages PM1, PM2, and PM3

11. Appendix A gives the pressure-time histories as digitized and plotted from the analog data for each of the pressure gages in the first three tests. Pertinent information taken from these records is given in Table 4. Figures 5 through 7 are comparative plots of the peak pressure, impulse, and time of arrival for each test. Data from several gages are missing due to gage malfunction or erroneous readings. As can be seen from the results, peak pressures occurred near the bottom of the wall and were on the order of 4,300 psi.

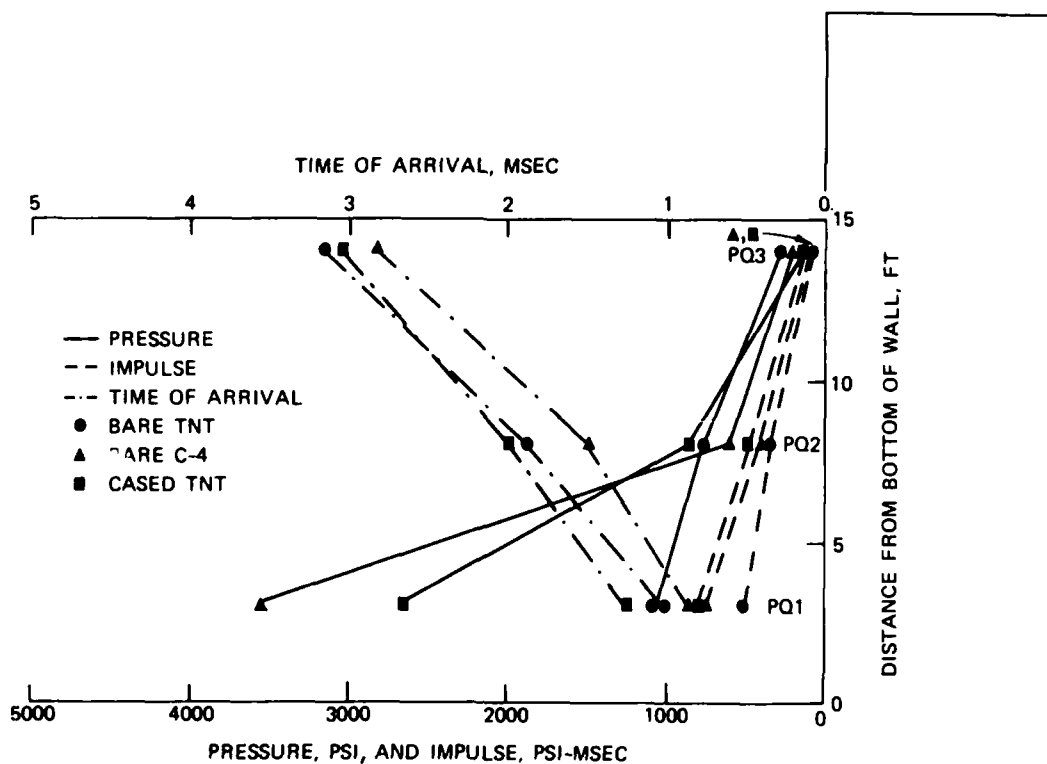
Figure 6. Comparison of blast pressure data for gages PQ1, PQ2, and PQ3

- a. Comparison of the peak pressures shows that, as expected, the greatest pressures existed near the bottom of the wall. Comparison of the peak pressures at gage PQ1 shows extraordinary differences between the C-4, TNT, and cased TNT charges. However, these differences are plausible since the gage was located near the angle of incidence where reflection factors changed drastically. In general, no conclusions could be drawn as to the relative effectiveness of the different charges by examination of the peak pressure data alone.

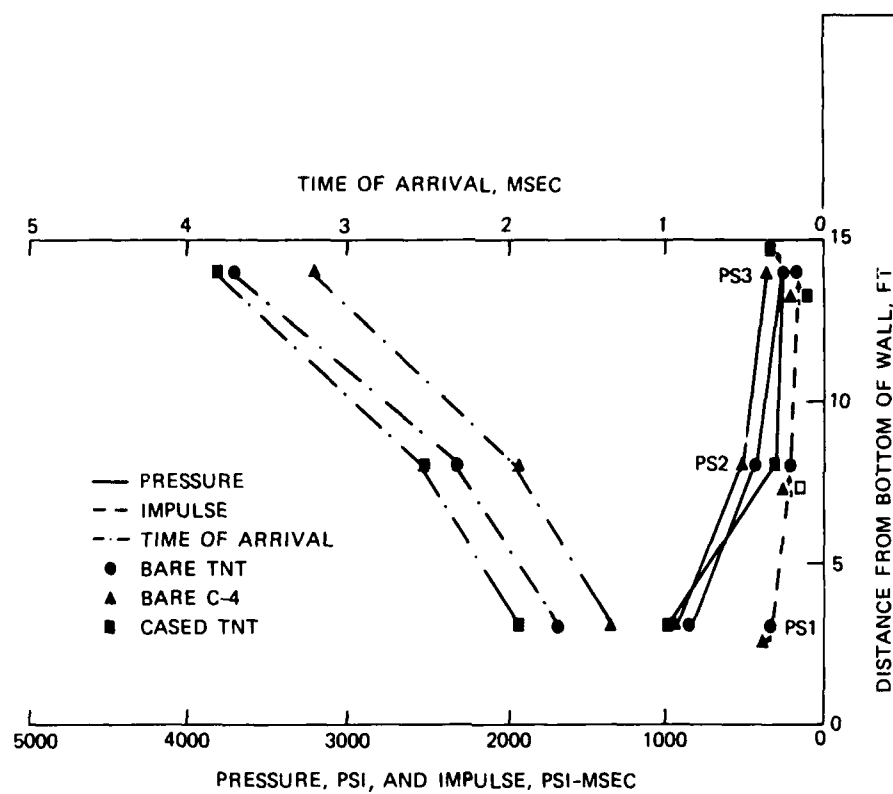
Figure 7. Comparison of blast pressure data for gages PS1, PS2, and PS3

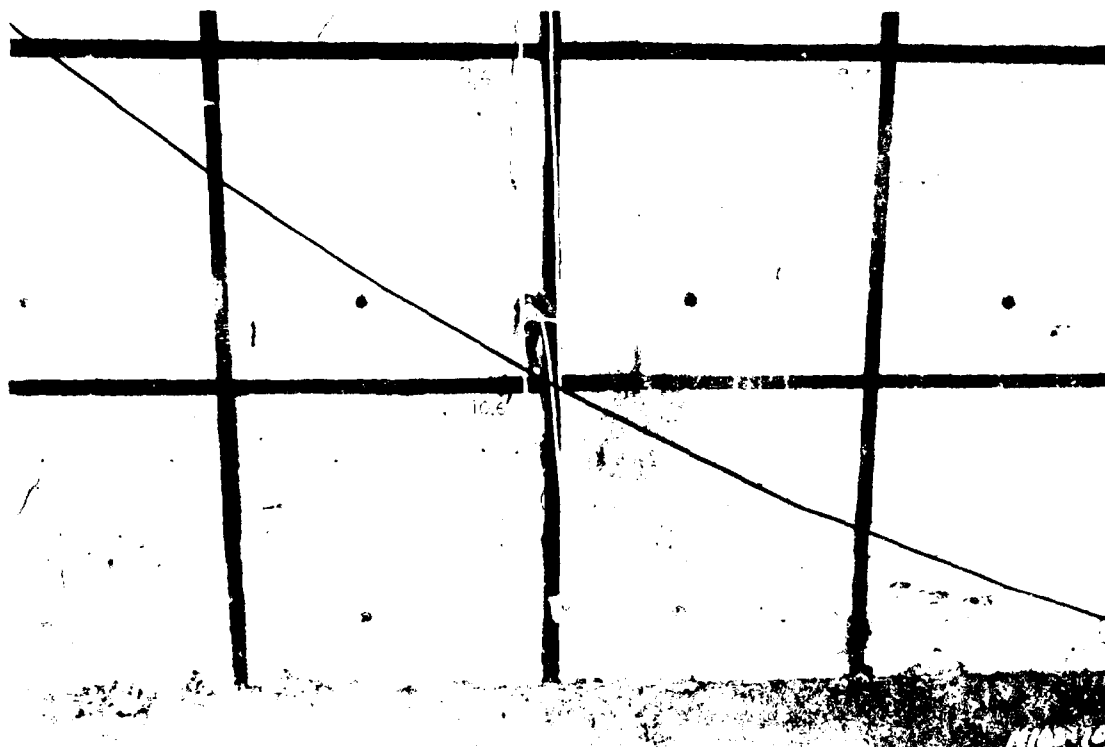
Figure 11. Crack pattern near bottom center rear of wall resulting from Test 1

- a. Test 1. The test resulted in no measurable permanent deflection. Some of the existing hairline cracks were widened and a few new cracks formed on the rear of the wall (Figure 11). The front of the wall saw no damage other than some of the existing 4 in. of Styrofoam insulation being blown off, and blackening of the wall surface (Figure 10). There was a noticeable crack formed in both of the side walls (Figure 12a and b).
- b. Test 2. Spalling occurred on both the front and back of the wall. The spall on the front wall was approximately 10 ft wide and 3 ft high at the highest point (Figures 14 and 15); on the rear, it was approximately 6 ft wide and 2 to 3 ft high (Figures 16 and 17). The spall penetrated no deeper than the depth of the inside of the rebars (approximately 4 in.) on both the front and back. There was a 4- to 5-ft-high large crack at the

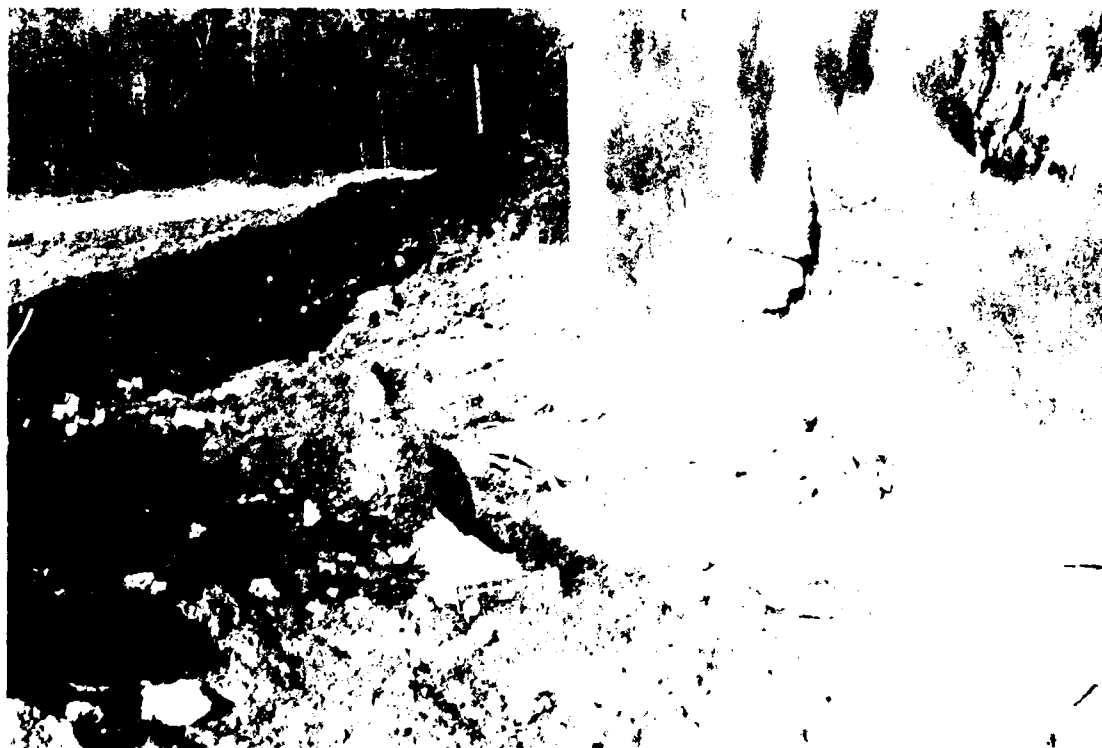
Figure 14. Crater and front wall damage from C-4 detonation

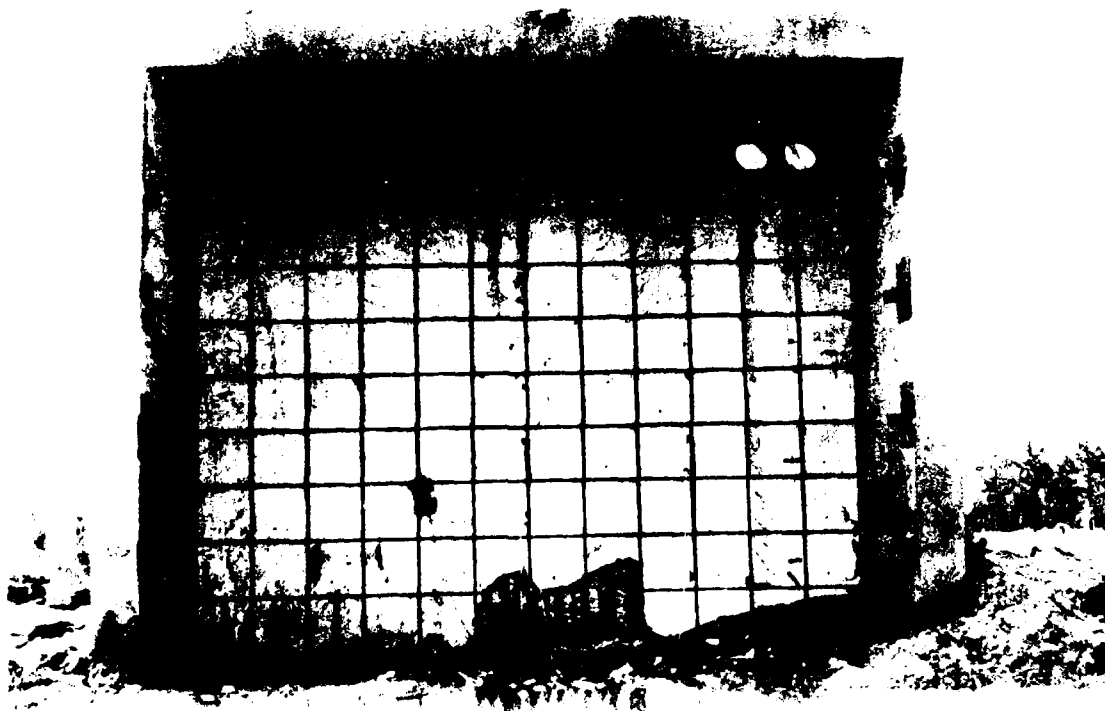
Figure 16. Overall view of damage to rear of wall from Test 2

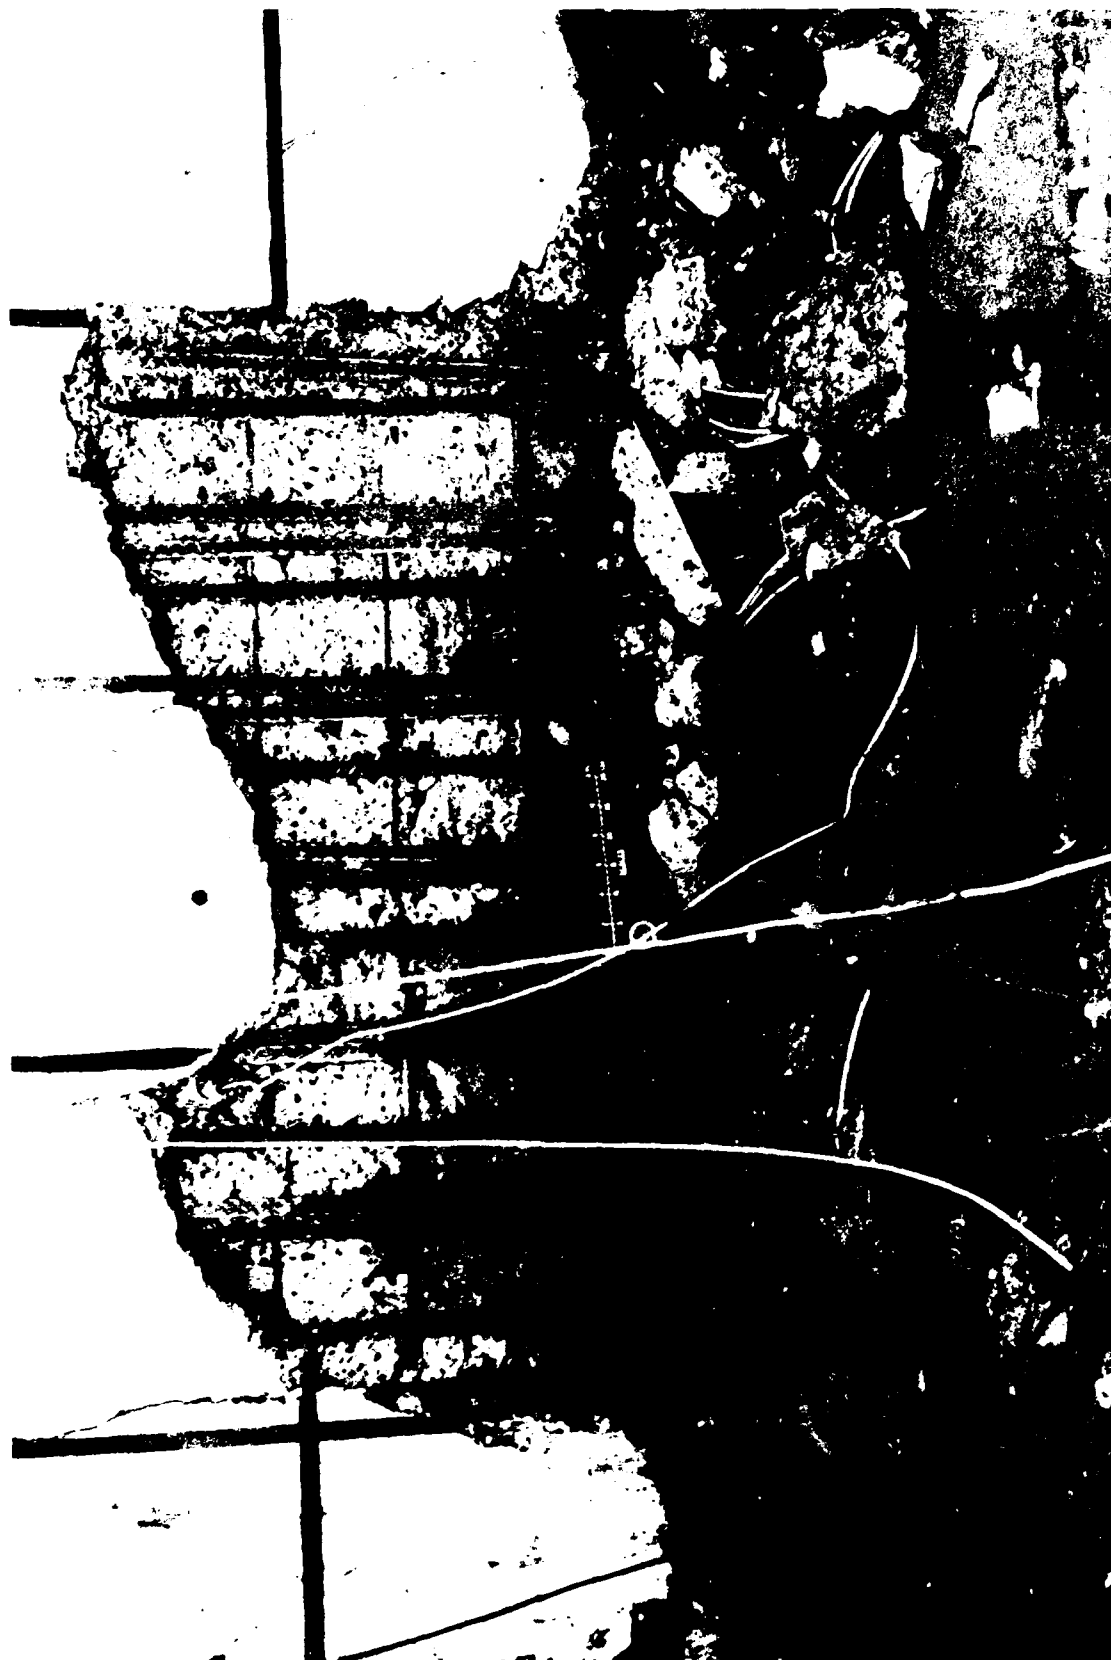
Figure 17. Close-up of spalled area on rear of wall from Test 2

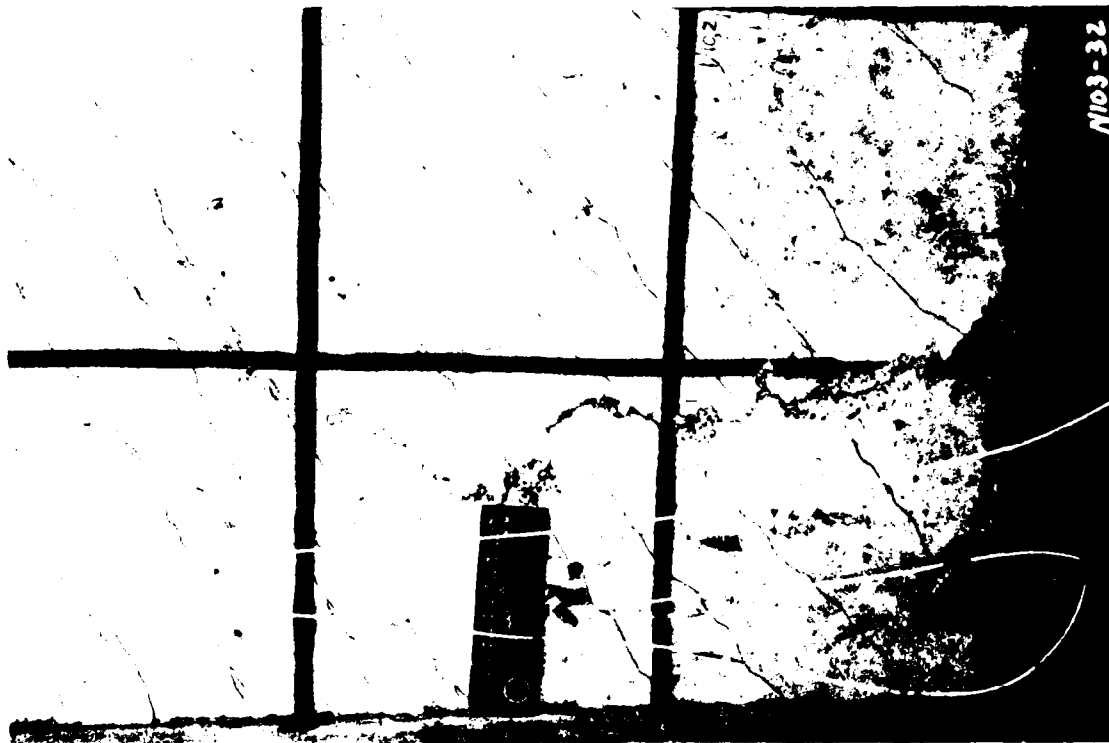
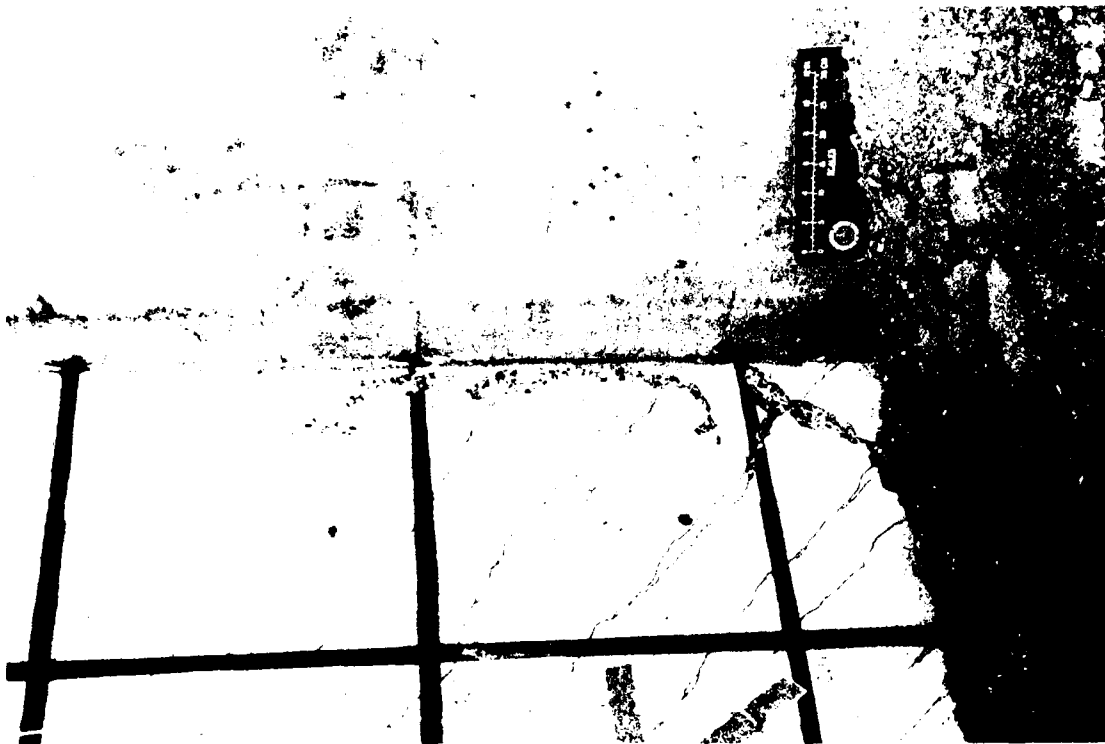
Figure 18. Cracks formed near side supports from Test 2

a. Intersection with test side wall

b. Intersection with right side wall

bottom of the wall near both side walls (Figure 18). There was a 2-in. permanent deflection on the No. 8 dowels on the rear face near the bottom of the wall.

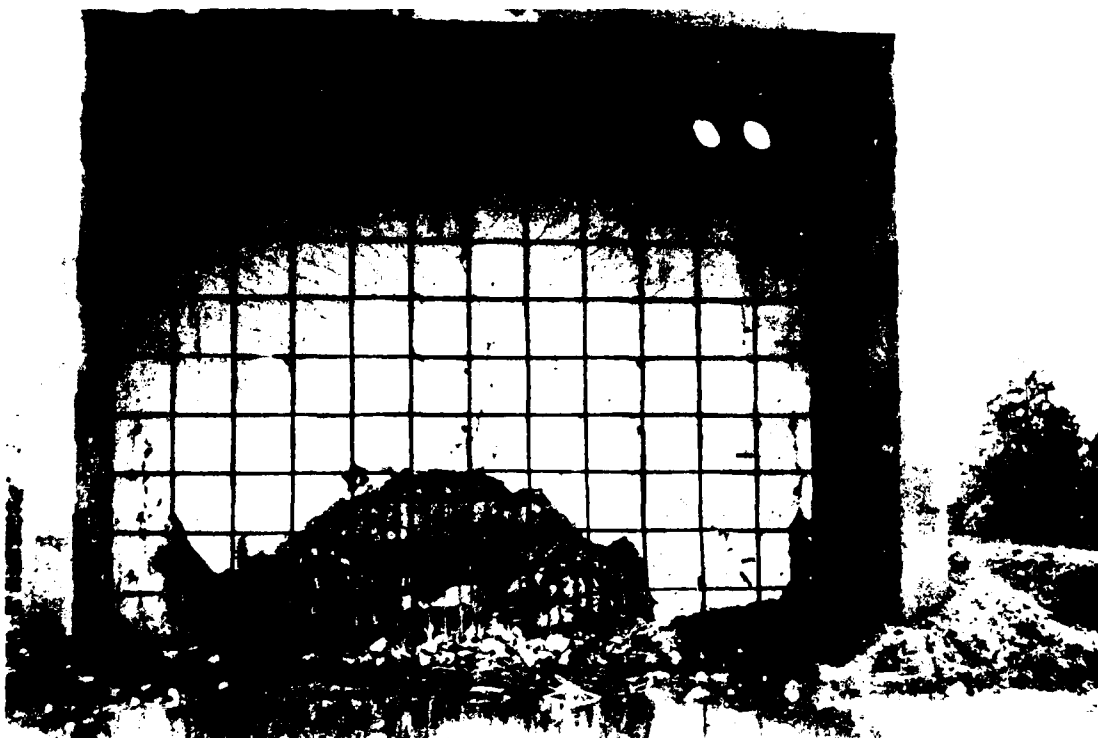
Figure 22. Damage to rear of wall from Test 3

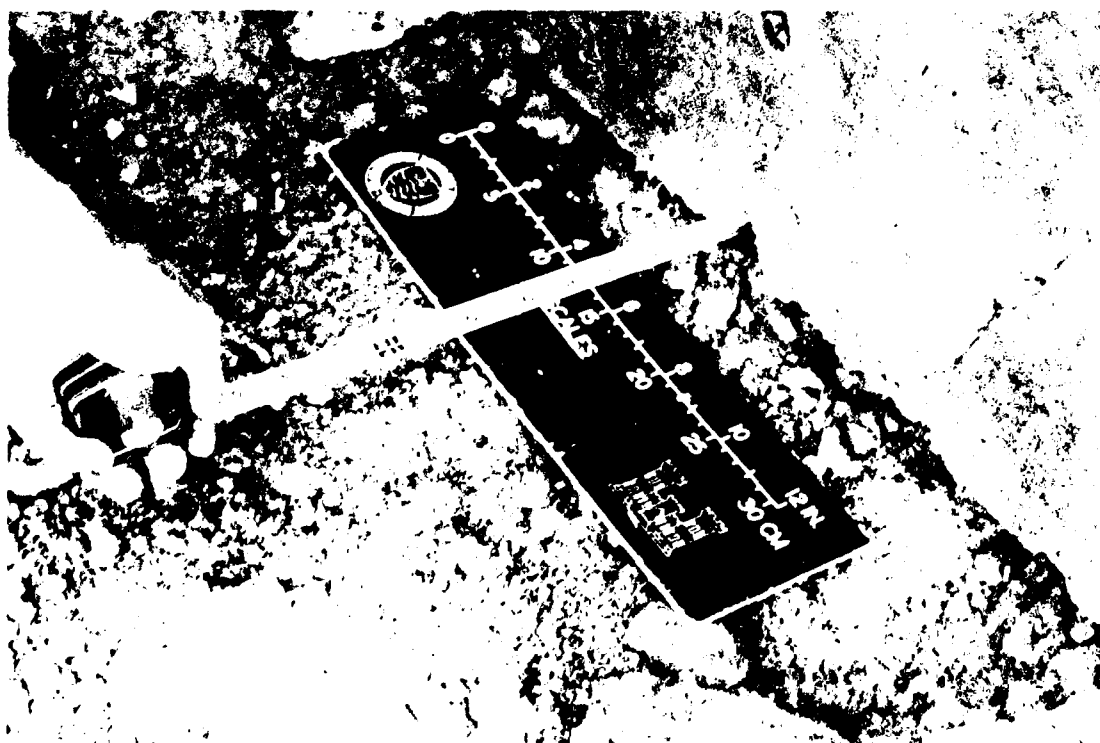
Figure 26. Close-up of bottom of wall showing extent of permanent deflection

- d. Test 4. There was no spalling on either side of the wall except near the free edge due to edge effect. There was major cracking of the outside of the wall (Figure 24) with a permanent deflection of the wall surface of approximately 0.5 in. inward. The inside of the wall was cracked (Figure 25) and the bottom of the wall (at the cold joint) was deflected 4.5 in. (Figure 26).
